Manhole Inspection Summary

Manhole # S11EE2027MH

Inspection ☐ Is Incomplete Rating: **3) Fair**

Location Address: **2234 CROSS COUNTRY BLVD**

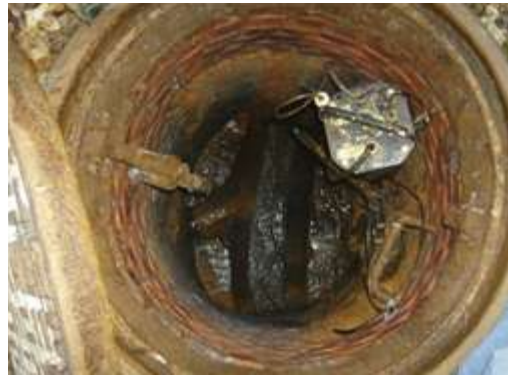
Top View

Corroded steps. Frame leaks.
Adjustment, Corbel and Barrel infiltration.

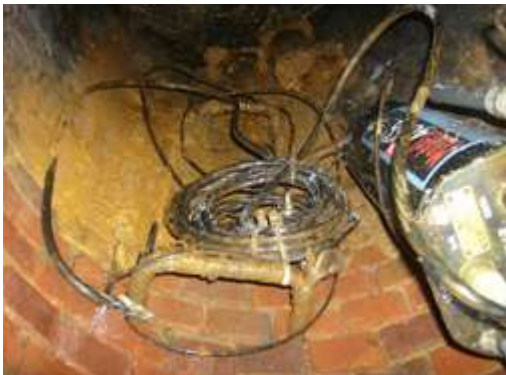
Defect

Corbel and Barrel infiltration.

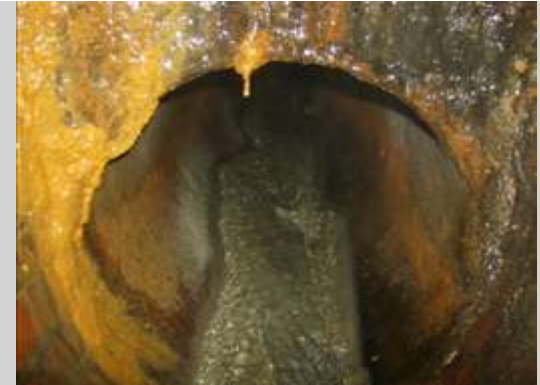
21 in. Circular Gravity Sewer Pipe Out @ 12 O'Clock

Invert Depth: **12.30** (ft.) Flow Characteristics: **Slow**

Infiltration: **None** Pipe Seal Cond: **Unknown**

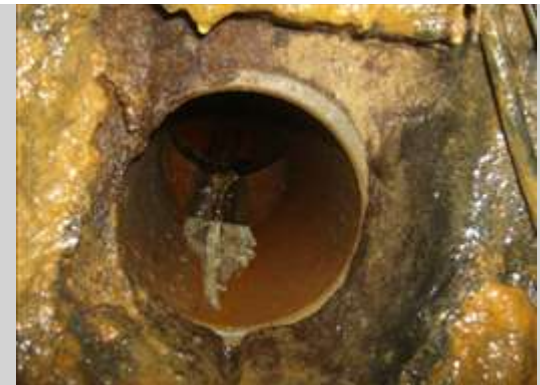
8 in. Circular Gravity Sewer Pipe In @ 3 O'Clock

Invert Depth: **8.51** (ft.) Flow Characteristics: **Slow**

Infiltration: **None** Pipe Seal Cond: **Unknown**

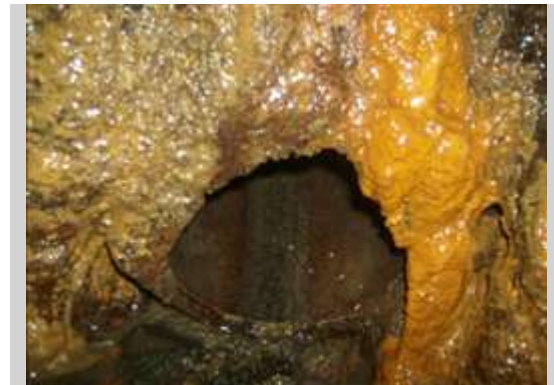
Drop In @ 3 O'Clock

Drop: **Outside** Rod and Bar
Angled: **Yes** Reading: **9.43** (ft.)
Inv Depth: **10.43** (ft.)

Drop Condition: **Open**

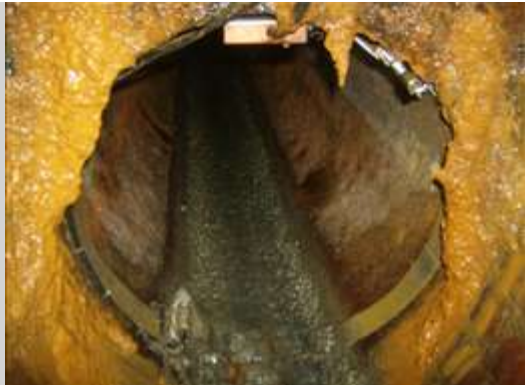
Pipe In @ 6 O'Clock

Invert Depth: **12.10** (ft.) Flow Characteristics: **Slow**

Infiltration: **None** Pipe Seal Cond: **Unknown**

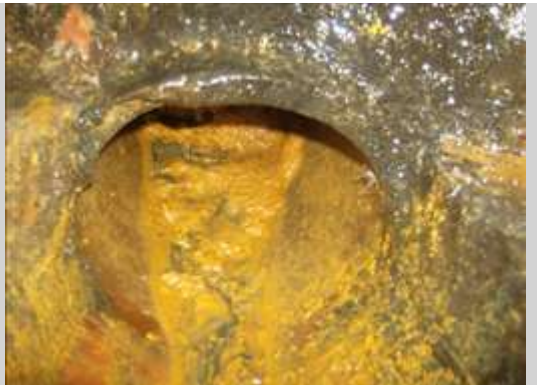
Pipe In @ 9 O'Clock

Deposits: ☐ None ☒ **Mud** ☐ Sludge ☒ **Debris** ☐ Grease

Silt Depth: **1** (in.) Deposits Extent: **Light**
